Estates and Facilities Alert

Ref: EFA/2010/003 Issued: 29 March at 14:30

Anti-ligature curtain rails (including shower curtains): risks from incorrect installation or modification

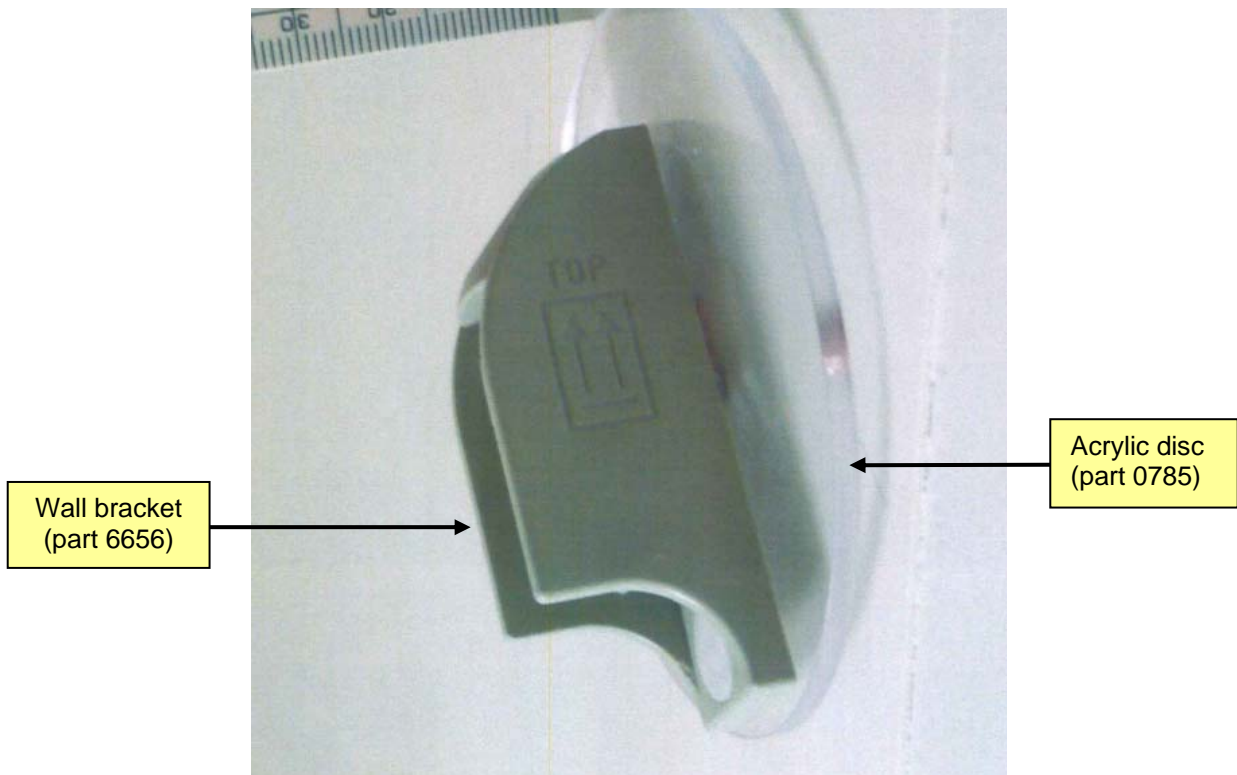
Figure 1

- c) One screw should be used per bracket for curved rails, located centrally to allow the bracket to rotate during collapse. An additional clear acrylic disc should be used on uneven or textured wall surfaces to ensure rotation of the bracket (see Appendix, Figures 1 and 2). However, two screws are required per wall bracket for straight rail installations. The omission of the second screw in this incident may have made it easier for the patient to use the wall bracket as a point of ligature.

Silent Gliss anti-ligature wall bracket mounted on wall with single screw – set up for a curved rail installation (disc normally only required for use on uneven or textured wall surfaces)

5. When installing anti-ligature curtain rail systems (all makes) it is vital that manufacturers' instructions are followed. Where possible, installation should be carried out only by persons trained by the manufacturer or approved distributor.

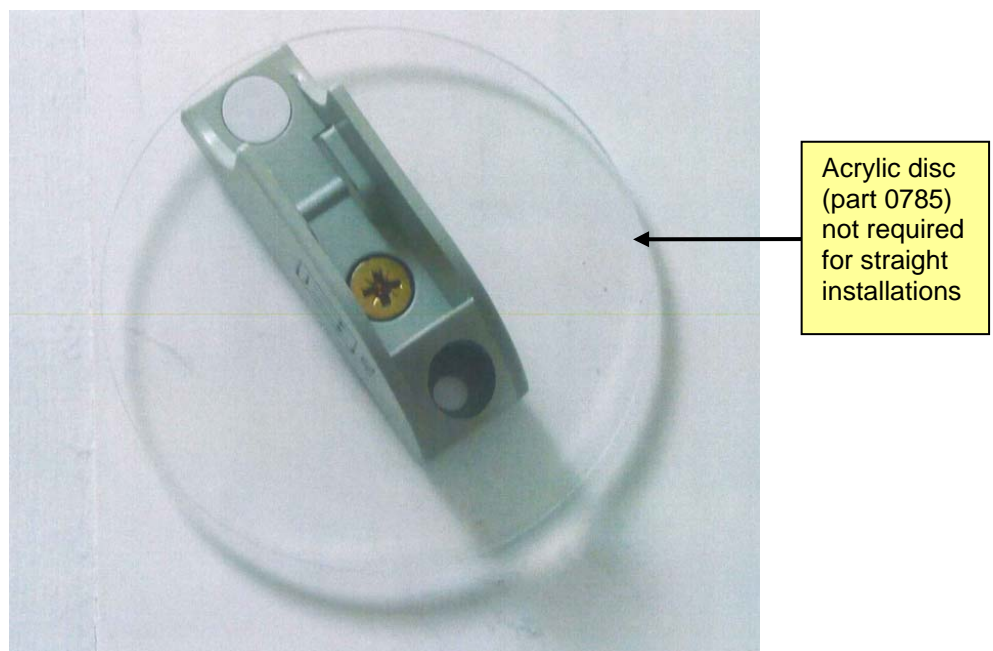
Figure 2

1. **Incident 1** involved a Silent Gliss 6650 system.
 - a) The manufacturer's installation instructions differ for straight rail installations (wall to wall) and curved rail installations (those which contain corner sections). In this case, the system was a straight rail type but the wall bracket was installed and configured for use with a curved rail (see point d below). Other Silent Gliss curtain rails in the hospital were also found to be installed incorrectly by a third party.

Silent Gliss anti-ligature wall bracket mounted on wall with single screw – incorrect set up for a straight rail installation (and rotated upside down).

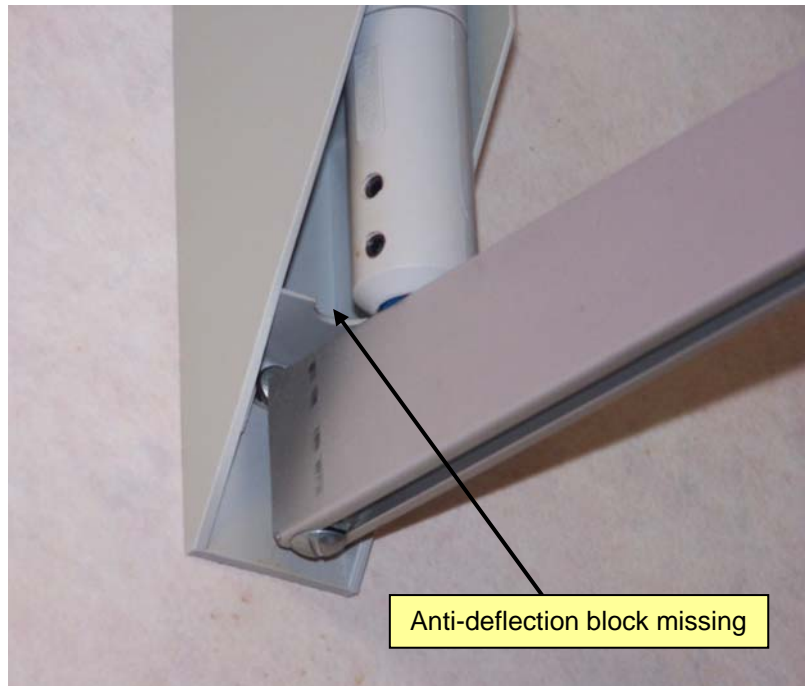
2. **Incident 2** involved a Tidy Joint[®] Safe Trak system (see Appendix, Figures 3 and 4).
 - a) It is likely that some components were not installed as required, as they were missing after the incident. Despite a search of the area these were never found.

- b) One of the missing components, the anti-deflection block, was designed to correctly position the curtain rail and reduce the risk of it being used as a point of ligature. The manufacturer's installation instructions state that the anti-deflection block should be secured in place.

Figure 3
Tidy Joint® Safe Trak - incorrect installation

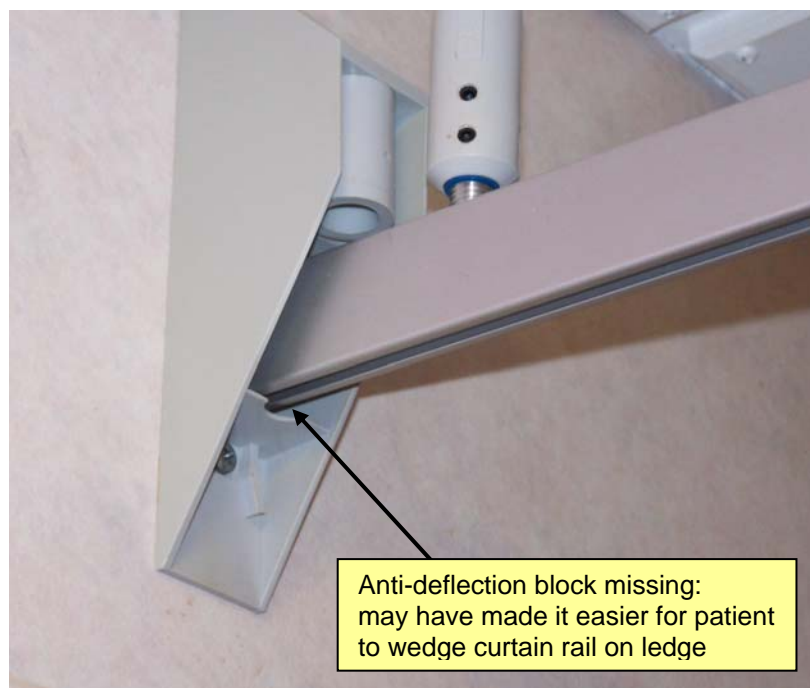
Figure 4
Tidy Joint® Safe Trak – modified by patient to prevent rail dropping

6. If modifying an anti-ligature curtain rail system (e.g. to reduce non-ligature risks) care should be taken to ensure that (new) ligature risks are not introduced and that the anti-ligature properties of the system are not compromised. If in doubt, contact the manufacturer / supplier for advice.
